# Manhole Inspection Summary

Manhole # S53M\_\_009MH

Insp Date: **7/21/08 2:42 PM**

**Location** Address: **rear 822 s decker st**

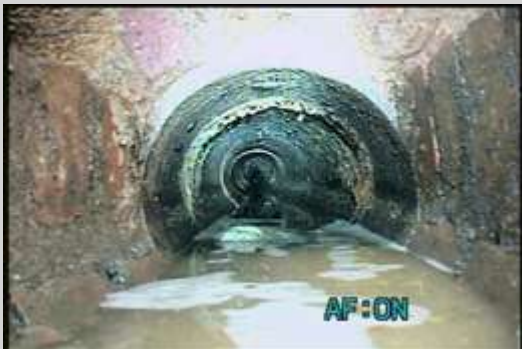
3 O'Clock Inflow

8 in. Circular Gravity Sewer  
Pipe In @ 3 O'Clock

Pipe Material: **Clay** ☐ Pipe Lined

Invert Depth: 6.10 (ft.) Flow Characteristics: **Slow**

Deposits: ☒ **None** ☐ Mud ☐ Sludge ☐ Debris ☐ Grease

Infiltration: **None** Pipe Seal Cond: **Unknown**

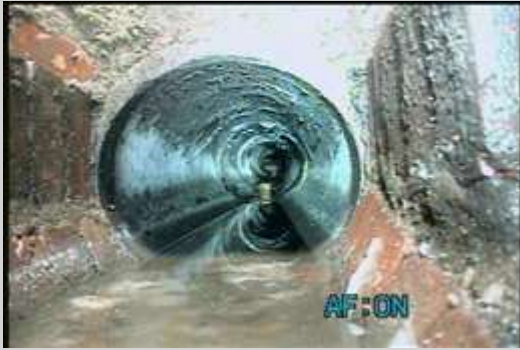
6 O'Clock Inflow

8 in. Circular Gravity Sewer

Pipe In @ 6 O'Clock

Pipe Material: **Clay** ☐ Pipe Lined

Infiltration: **None** Pipe Seal Cond: **Unknown**
